**AFRL-RQ-WP-TR-2014-0231**

**RAPID RESPONSE RESEARCH AND DEVELOPMENT  
(R&D) FOR THE AEROSPACE SYSTEMS DIRECTORATE  
Delivery Order 0021: Engineering Research and Technical Analyses of  
Advanced Airbreathing Propulsion Fuels**

**Subtask: Engine and Pump Studies Utilizing JP-8 and Alcohol-to-Jet (ATJ)  
Blends**

**AUGUST 2014  
Interim Report**

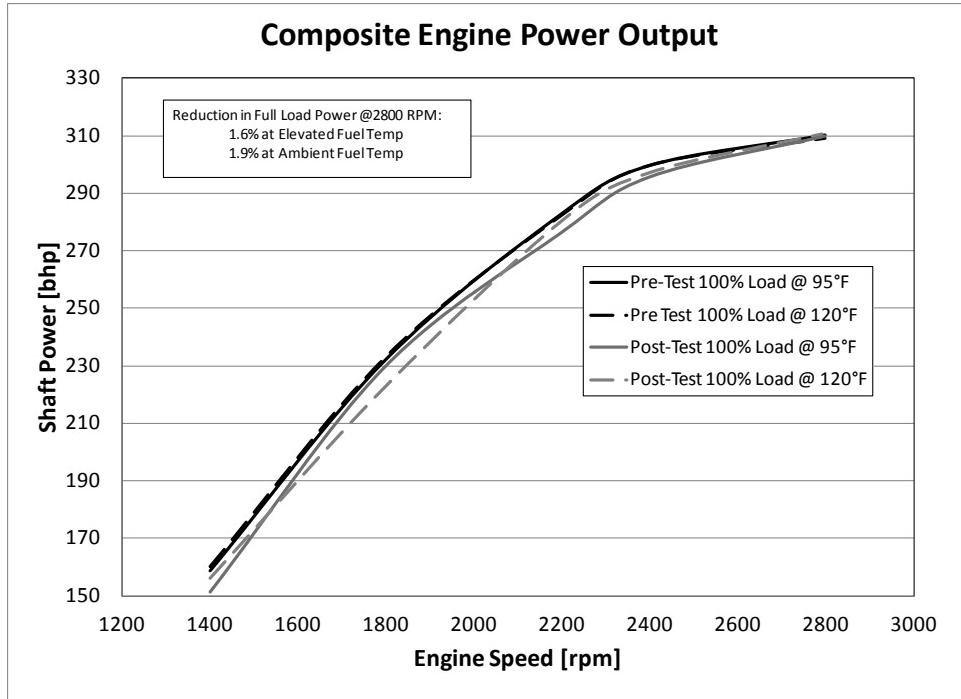
**Figure A-7. Composite Engine Power Output**

The plots below show the pre and post test engine power curves. Figure A-7 reveals the pre, and post test composite full load power curve for both fuel inlet temperatures of 95°F and 120°F. After 210-hours of operation using ATJ JP-8, the engine max power had decreased by 1.9% at ambient fuel temperature and 1.6% at the elevated 120°F fuel temperature.

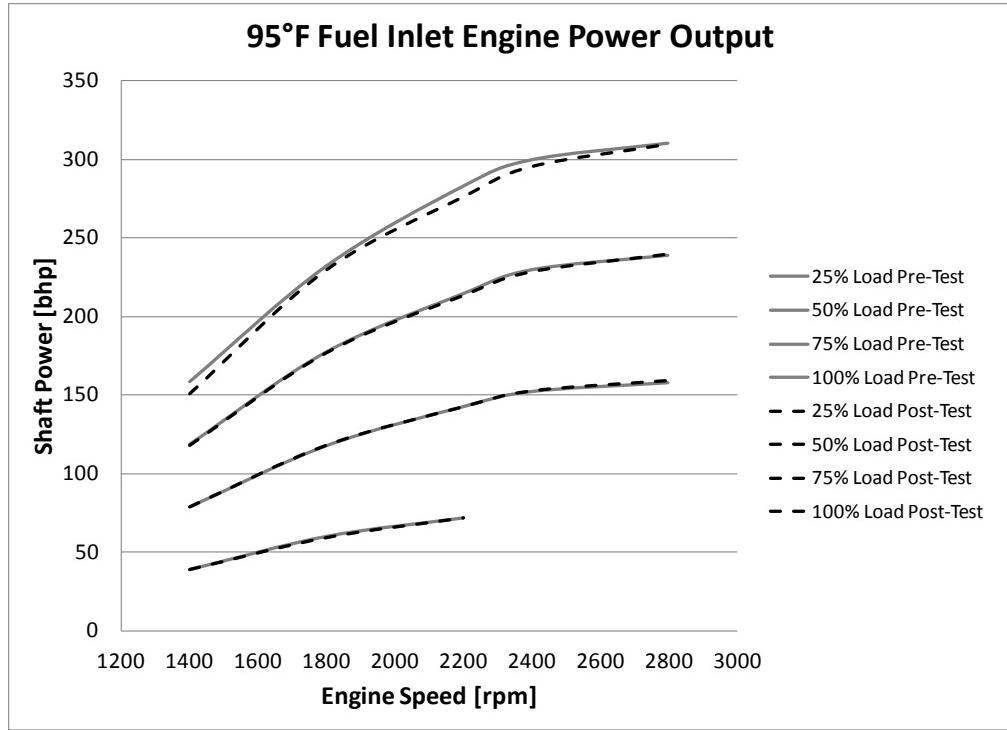
**Figure A-8. Pre & Post Test Engine Power Output as 95 °F Fuel Inlet Temperature**

Figure A-8 and Figure A-9, shows the pre, and post test engine power output performance maps generated with JP-8 fuel at the 95°F, and 120°F fuel inlet temperatures respectively, for the 25%, 50%, 75%, and 100% pedal positions. Slight power deviations are seen at the lower engine speeds, more pronounced at the 120°F fuel inlet condition, after 210-hours of operation with the ATJ/JP-8 blend. Exhaust emission data was taken at each one of the speed/load points on the maps. Figure A-10 and Figure A-11, shows the pre, and post test engine torque output performance maps generated with JP-8 fuel at the 95°F, and 120°F fuel inlet temperatures respectively, for the 25%, 50%, 75%, and 100% pedal positions. The torque variations reflect the power deviations noted after engine operation on the ATJ/JP-8 blend.

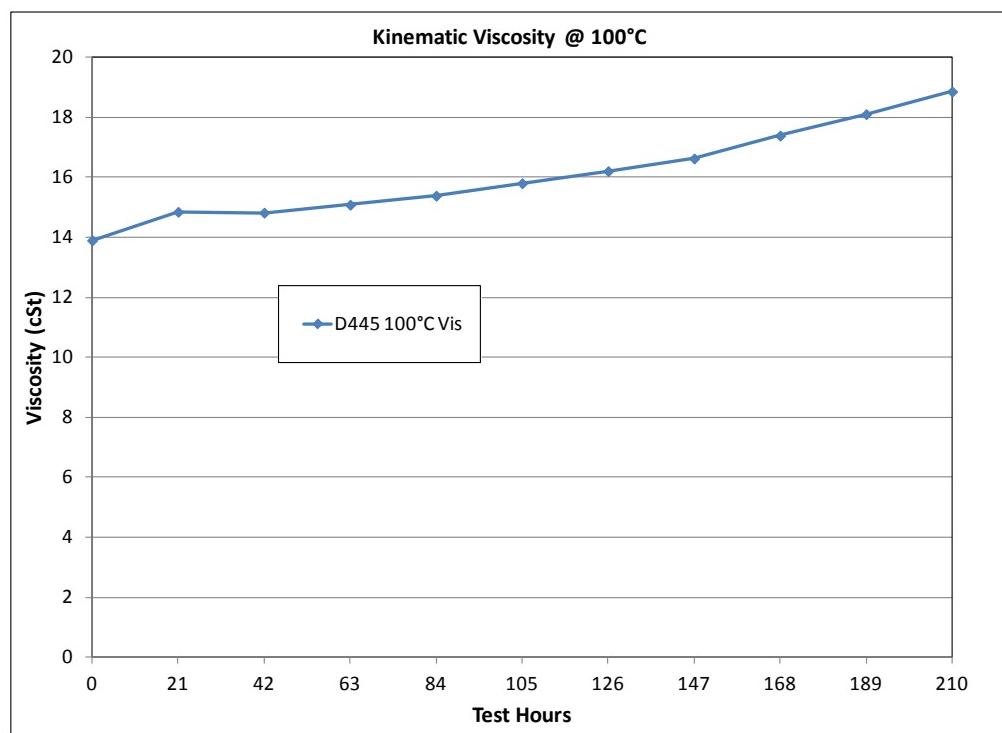
**Figure A-19. Lubricant Kinematic Viscosity Change**

Figure A-19 shows the lubricant kinematic viscosity change throughout testing with the 5W-40 grade lubricant. The lubricant did thicken, increase out of grade ( $>16.3$  cSt @  $100^{\circ}\text{C}$ ) prior to the 210-hour change, but as shown in Figure A-20 retained reserve alkalinity, or Total Base Number (TBN). Generally in engine testing, the TBN should be kept greater than 4.0, or the TBN should be greater than the Total Acid Number (TAN), to ensure the lubricant provides adequate engine protection. Since the lubricant retained its alkalinity during testing, no lubricant change was required.

The soot accumulation in the lubricant is shown in Figure A-21. A comparison of the soot accumulation and the viscosity change suggest soot accumulation in the lubricant was at least partially responsible, along with lubricant oxidation, for the viscosity increases that are shown in Figure A-19.

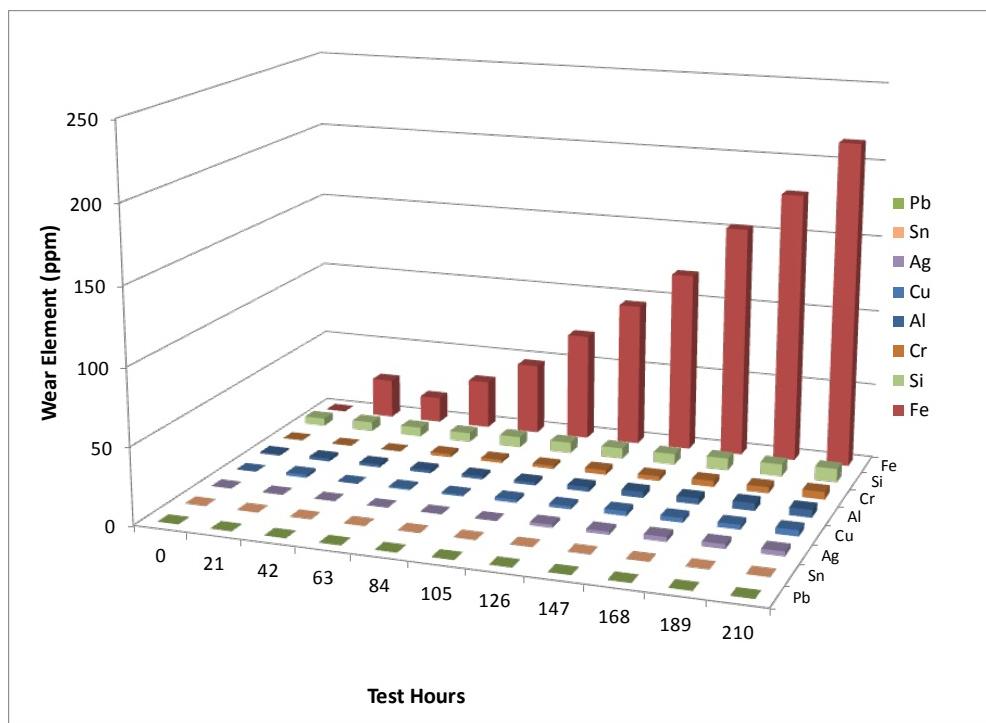
**Figure A-22. Wear Metals from Used Lubricant Elemental Analysis**

Elemental analysis of the lubricant for typical wear metals is shown in Figure A-22. The only element with any accumulation is iron (Fe), but the levels are typical for 210-hours operation in the FORD 6.7L engine. Additive elements are shown in Figure A-23, with the major additive elements of Ca, P, Mg, and Zn revealing concentration with test duration.

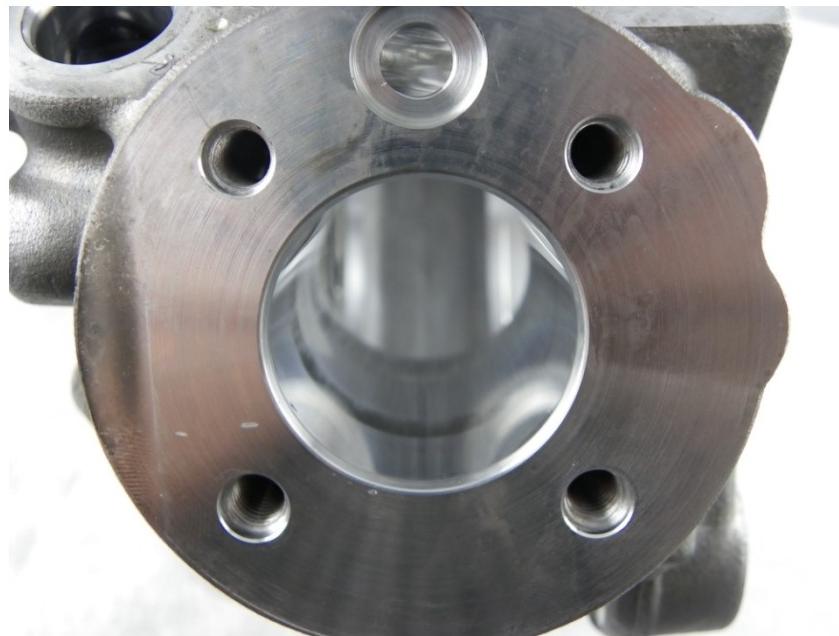
**Figure A-26. AF8646 ATJ/JP-8 Blend, Post Test, Left Pump Bore**

follower assembly. The wear present on the pump body bore and cam follower surfaces were found to be similar to previous fuels testing. The bores in each of the pumps showed some polishing on their surface from interactions with the cam follower. Markings tended to be present primarily at the top and bottom of the travel area of the follower, which is consistent with areas of largest side loading present on the follower from the forces applied by the pumps camshaft and plunger return spring. A new unused pump also shows similar but smaller markings likely produced at end of line testing during manufacturing.

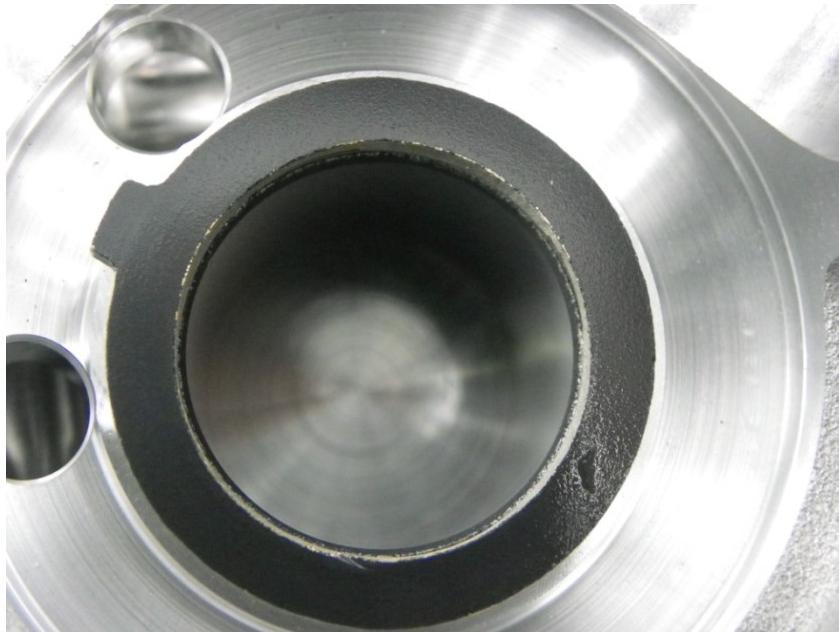
**Figure A-36. AF8646 ATJ/JP-8 Blend, Right Cam Follower Under Crown**

Figure A-36 shows the right cam follower under crown and the contact area with the high pressure plunger head. Figure A-37 shows the right hand high pressure plunger. Similar to the left hand assembly, polishing at this interface was visible, but no physical wear was tactilely distinguishable. The right barrel and plunger assembly wear was similar to that seen on the left, and similar to all previously run test fuels.

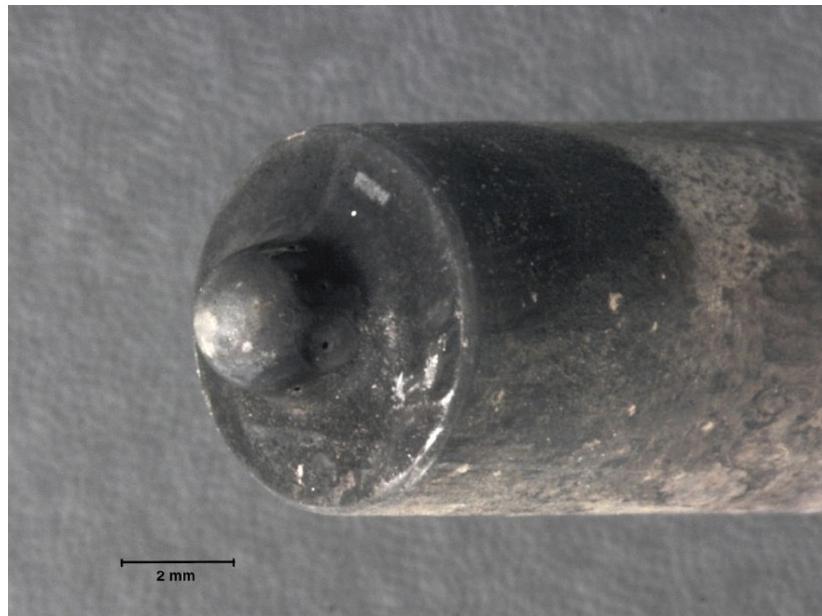
Figure A-42. AF8646 ATJ/JP-8 Blend, Injector Nozzle

Figure A-42 shows the injector nozzle tip. No substantial deposit formations were seen under low magnification. Figure A-43 below shows the injector needle tip. No abnormal wear, deposits, or markings were found on the tapered tip.

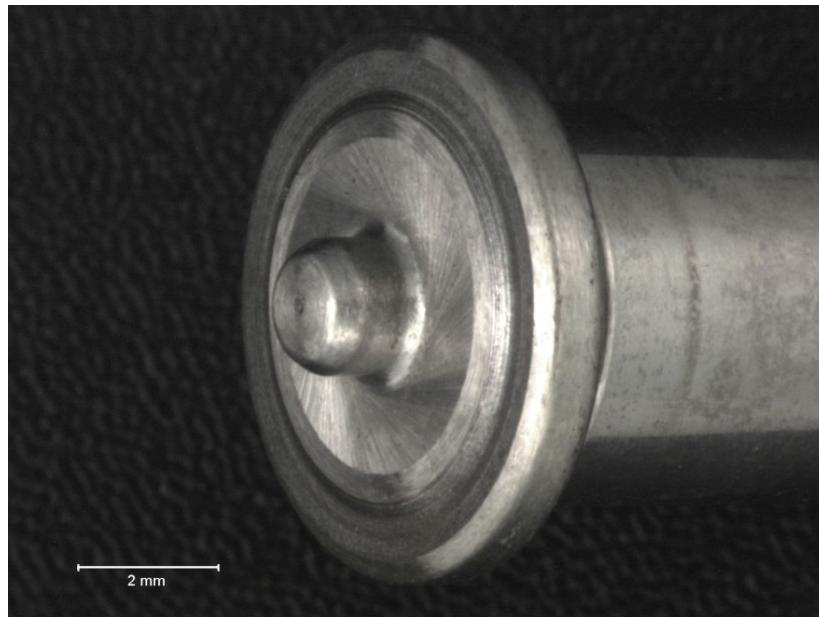
**Figure A-44. AF8646 ATJ/JP-8 Blend, Upper Hydraulic Coupler Piston, Profile**

Consistent with what was seen in previous testing, the only internal injector components showing any appreciable wear patterns were the upper pistons of the hydraulic coupling. As previously explained in the fuel system description section, the hydraulic coupler is used to translate the small linear movement of the piezoelectric-stack to a larger linear movement to operate the injector control valve and regulate needle lift. From the inspection, it appeared that the piezoelectric-stack imparts a slight side load on the upper piston causing a reacting wear scar to be formed on the outer piston surface. This wear scar was seen in each of the test fuels in previous testing, and was found to be slightly more severe in size and condition for the ATJ/JP-8 evaluation, but did not impact engine operation or emissions. Figure A-44 and Figure A-45 show the side profile of the upper hydraulic coupler piston. Although this wear did not impact the testing at hand, this type of wear is typical of wear that can be detrimental to fuel injector function if continued. Binding or sticking of the hydraulic coupler has the potential to impair the action of the control valve which can potentially result in no fuel being injected into the engine, or a constant flow of injected fuel. Either of these occurring during engine operation would require immediate fuel injector replacement to ensure proper engine operation.

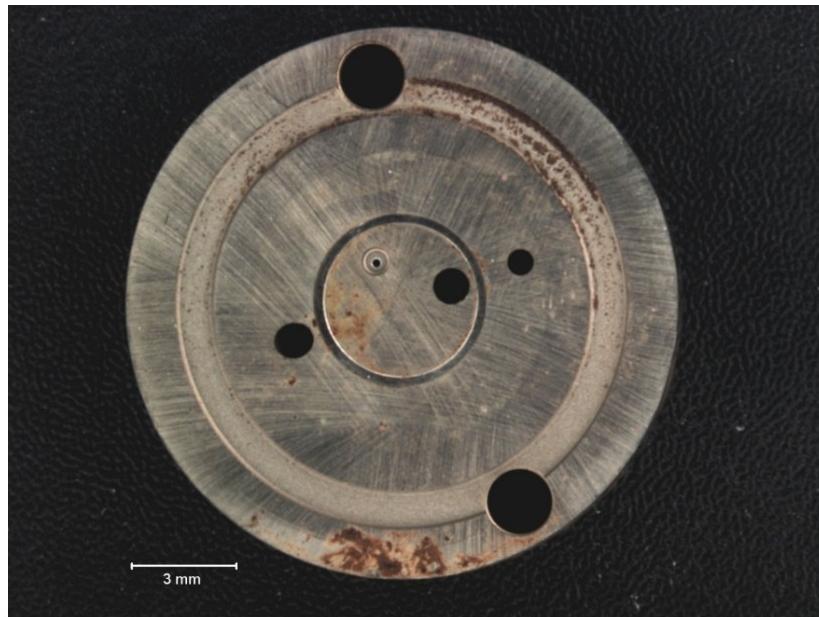
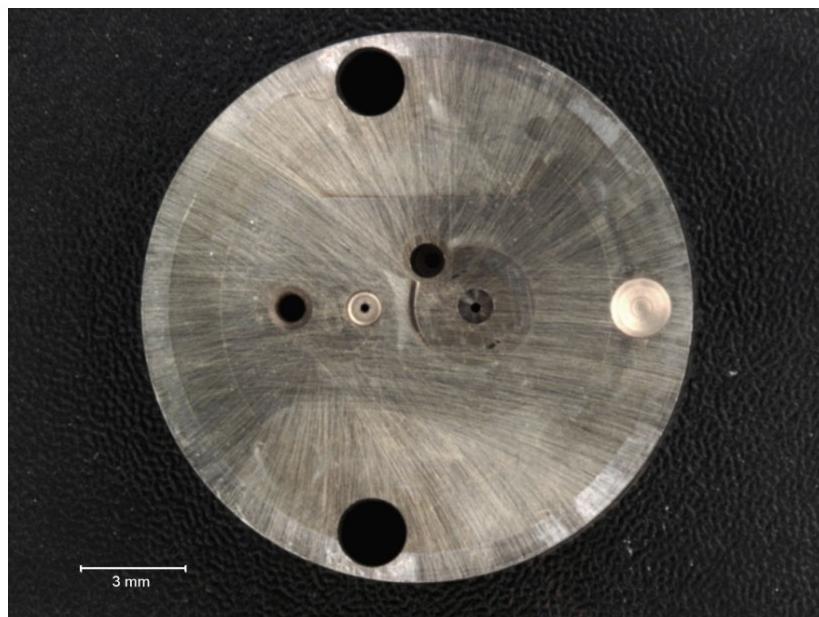
Figure A-46 and Figure A-47 show the upper and lower hydraulic coupler pistons contact surfaces respectively. No noticeable wear was seen on the piston surface interface, or at the heads of the piston at the piezoelectric stack and control valve interface.

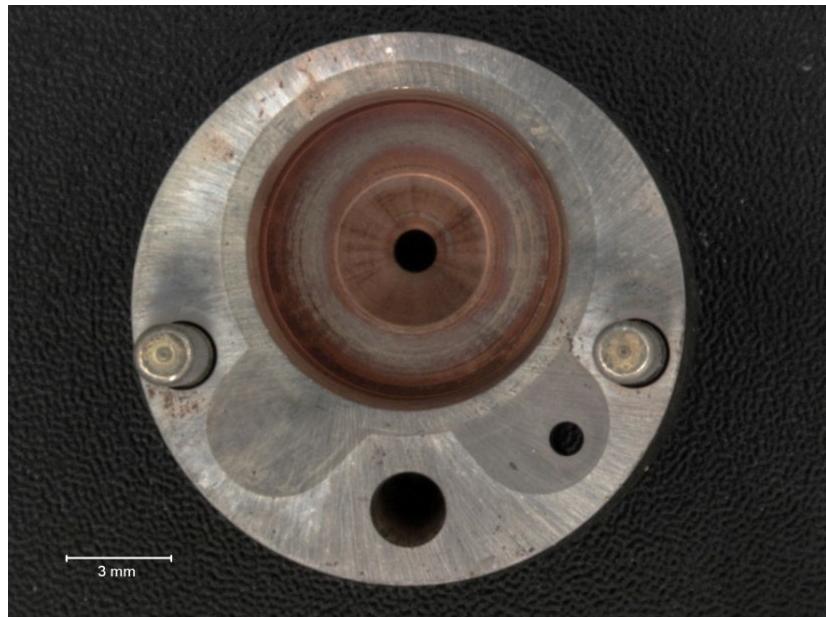
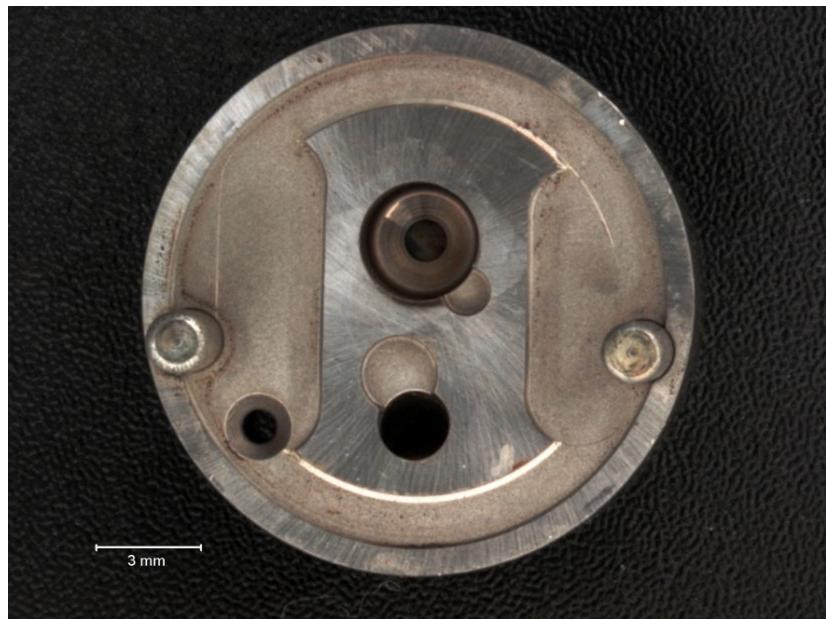
Figure A-48 and Figure A-49 show the top and bottom surfaces of the intermediate plate. This plate contains the fuel control passages used to manipulate the needle position. Some fuel deposition is seen in Figure A-48 that did not interfere with injector, or engine function.

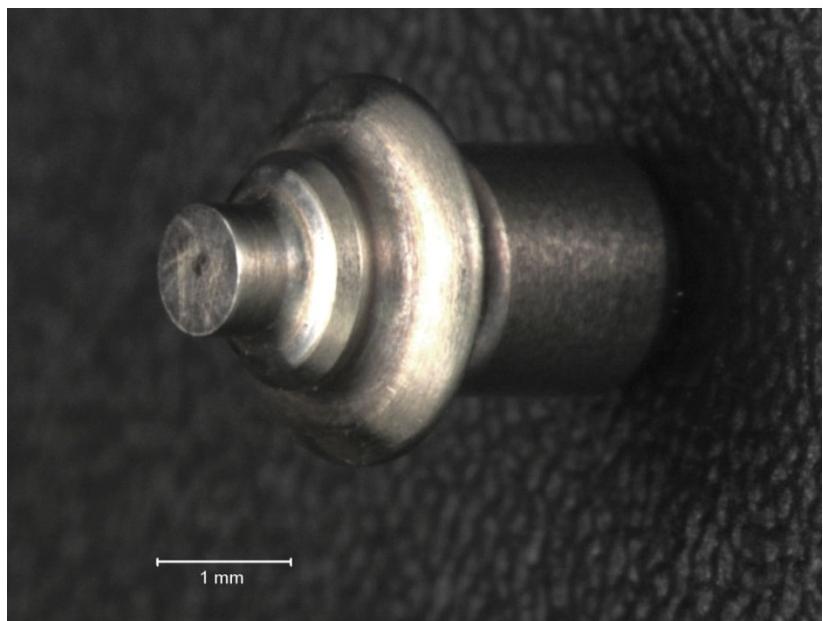
**Figure A-50. AF8646 ATJ/JP-8 Blend, Control Valve Plate (Top)**

Figure A-50 and Figure A-51 show the top and bottom of the control valve plate. Similar to previous testing, light fuel deposition was evident on the surfaces. The control valve sits in the bore shown in Figure A-51. The lower piston of the hydraulic coupler operates in the bore shown in Figure A-50.

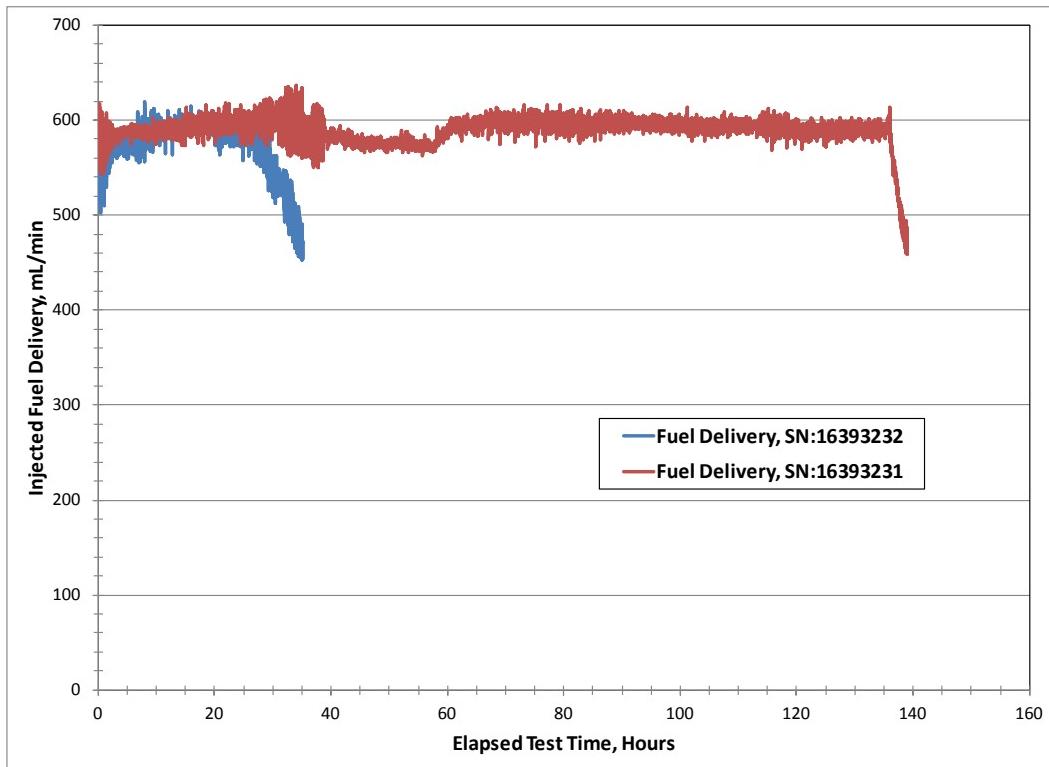
**Figure B-6. Fuel Flow Rate Histories for JP-8 Fuel at Elevated Temperature**

The fuel injection pump delivery histories are shown in Figure B-6 for both fuel injection pumps for operation on JP-8 fuel at 77°C fuel inlet temperature. Both injection pumps revealed slightly erratic delivery characteristics. Erratic delivery in these pumps could be due to metering valve wear or governor linkage wear. The reductions of the injected fuel delivery for the respective pump EOT times are evident in Figure B-6.

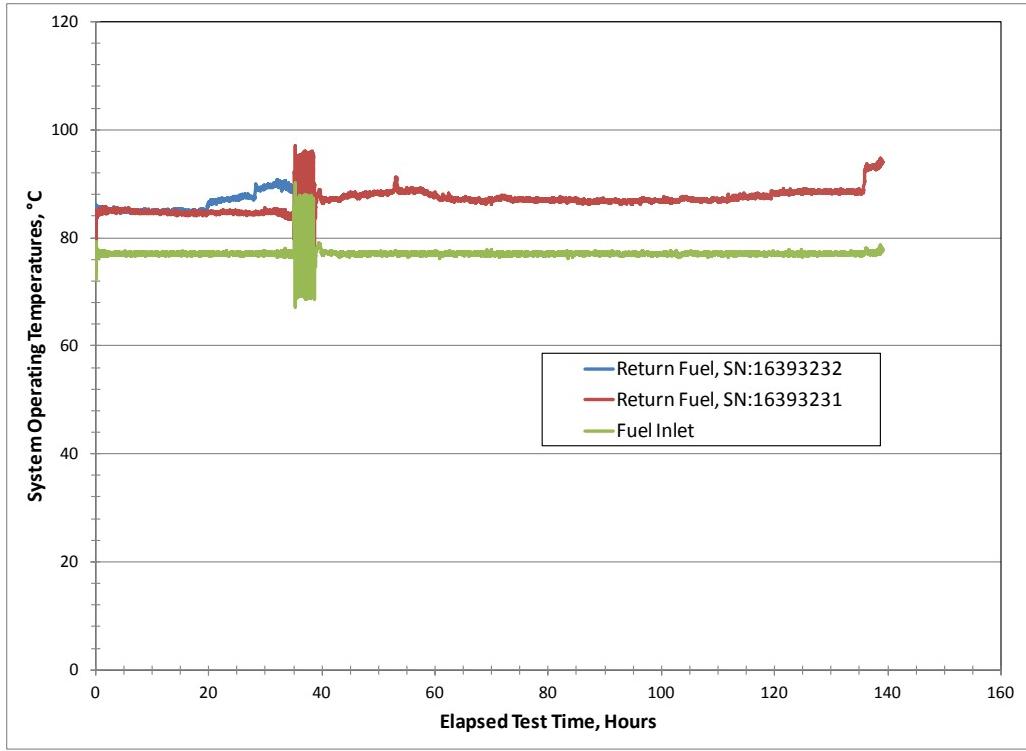
**Figure B-7. Fuel Inlet and Fuel Return Temperatures for JP-8 Fuel at Elevated Temperature**

The fuel injection pump temperature histories are shown in Figure B-7 for both fuel injection pumps for operation on JP-8 fuel at 77°C fuel inlet temperature. The test stand was converted to single pump operation with the removal of pump SN: 16393232. The fuel inlet temperature controller had a difficult time maintaining the fuel inlet temperature. The controller was re-tuned, after which a consistent fuel inlet temperature was maintained. It is possible the swings in fuel inlet temperature may have hastened the wear with pump SN: 16393231 after the 35-hour re-start, as the housing fuel return temperature settled at an elevated value after re-tuning the temperature controller. Prior to the test termination with either fuel injection pump, the housing fuel return temperatures are seen to increase, due to increased internal friction in the fuel injection pumps.

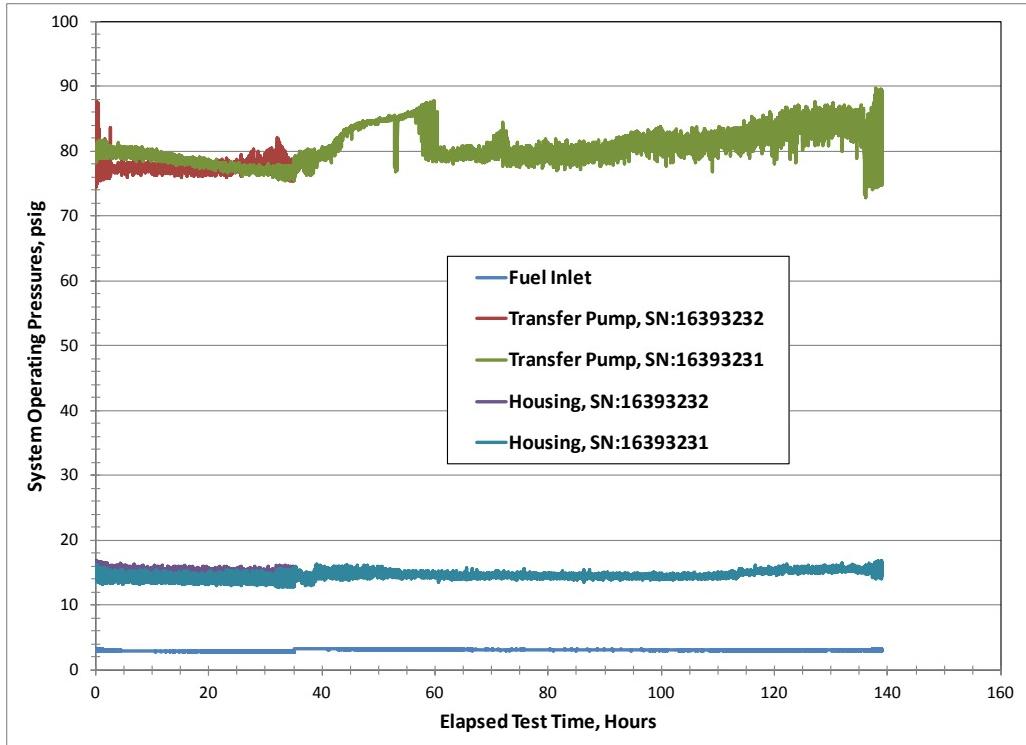
**Figure B-8. Fuel Inlet, Fuel Transfer Pump, and Housing Pressure Histories for JP-8 Fuel at Elevated Temperature**

Shown in Figure B-8 are the pressure histories for the elevated temperature JP-8 fuel testing. Fuel injection pump SN: 16393231 revealed a slight decrease in fuel delivery with a slight increase in housing pressure towards the end of testing. Housing pressure usually increases in these pumps when an excessive amount of high-pressure fuel leaks past the pumping plungers, indicating an increase of the plunger-to-bore clearance. The transfer pump pressure histories for both pumps indicate wear in the transfer pump and transfer pump regulator led to some erratic pressure histories, with pump SN: 16393231 being more erratic.

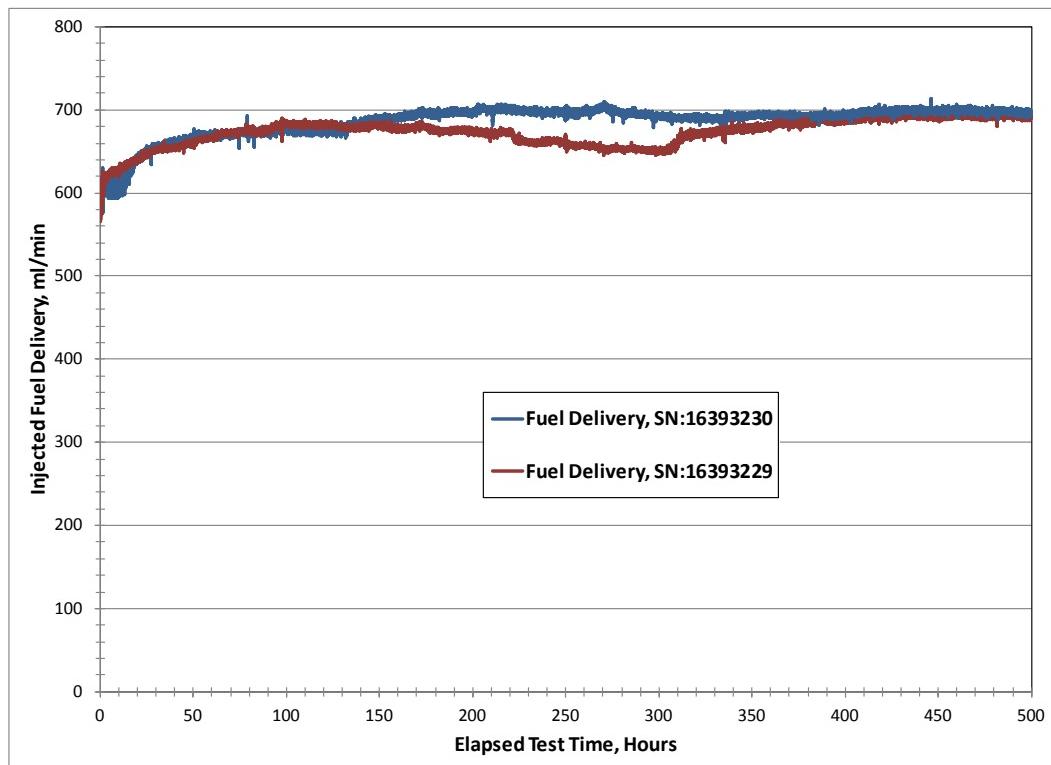
**Figure B-9. Injection Pump Delivery Histories for ATJ/JP-8 Evaluation**

The flow histories of the fuel injection pumps operating on the ATJ/JP-8 blend are shown in Figure B-9. From the onset of testing both fuel injection pumps exhibited an increase in fuel delivery. Pump SN: 16393230 increased injected delivery that eventually stabilized after 150-hours of operation. Pump SN: 16393229 exhibited more erratic delivery, with delivery rising and falling during testing. However both fuel injection pumps appeared to be operating normally on the ATJ/JP-8 blend at the conclusion of the 500-hours of operation.

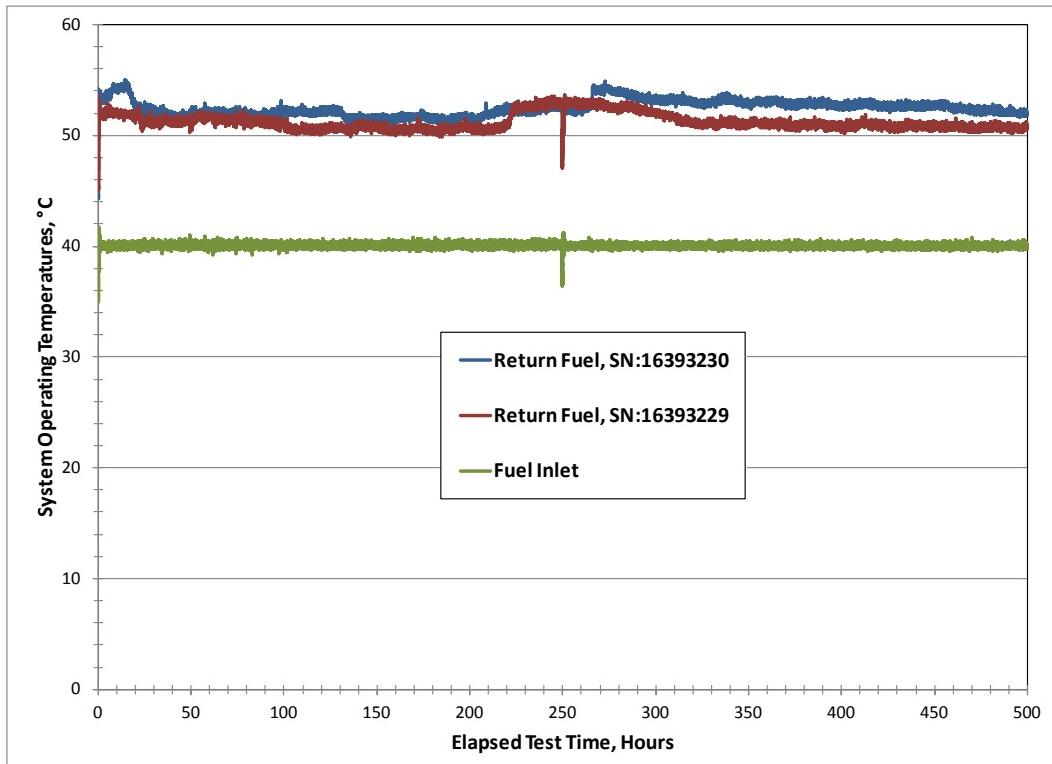
**Figure B-10. Injection Pump Temperature Histories for ATJ/JP-8 Evaluation**

The temperature histories of the fuel injection pumps are shown in Figure B-10. From the onset of testing both fuel injection pumps exhibited some form of erratic fuel return temperature behavior. For pump SN: 16393230 the return fuel temperature increased, usually a sign of increased internal friction, then decreased and increased again towards mid-test. Pump SN: 16393229 exhibited steady initial fuel return temperature that increased about mid-test indicating increased internal friction. Unusual wear in the pumps usually result in increases and variability of the fuel return temperatures. The fuel inlet temperature to both pumps was very consistent throughout testing.

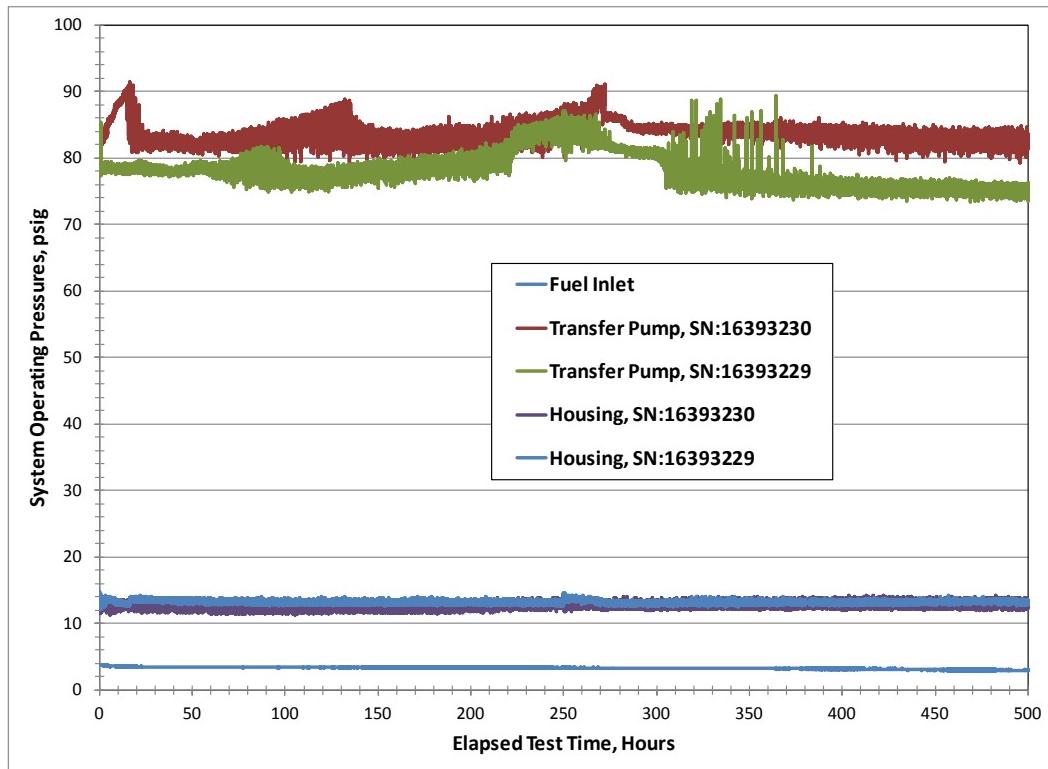
**Figure B-11. Injection Pump Pressure Histories for ATJ/JP-8 Evaluation**

Figure B-11 shows the fuel pressure histories for the test with the ATJ/JP-8 fuel. The fuel inlet and housing pressures for pumps SN: 16393229 and SN: 16393230 maintained a consistent level throughout the 500-Hours of operation. The transfer pump pressure for pump SN: 16393229 revealed a steady pressure for the first 200-hours, exhibited a sharp increase, followed by significant variability, then a decrease towards the end of the test. Pump SN: 16393230 reveals an initial transfer pump pressure spike, a stabilization, an increase again at mid-test, then stabilized pressure to the end of the test. The erratic pressure excursions of the transfer pump indicate pump liner, pump blade, and pump regulator wear. At 500-hours of testing the tops of both fuel injection pumps were removed for inspection, and the pump housings were free of wear debris. The housing for pump SN: 16393229 is shown in Figure B-12 and the housing for pump SN: 16393230 is shown in Figure B-13. Also note in both figures the lack of brown staining of the housing components.

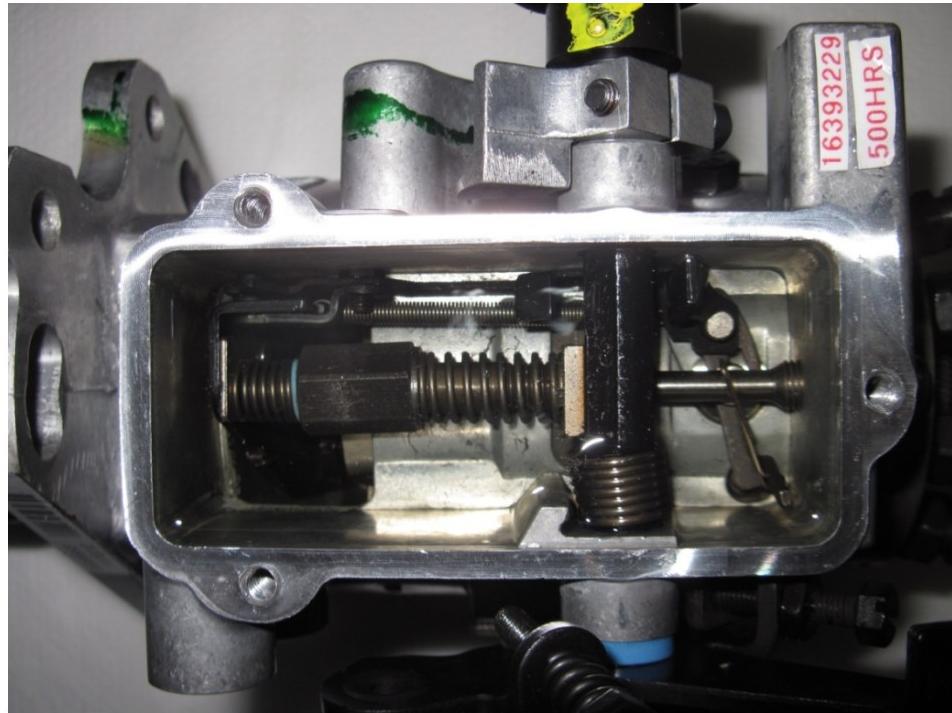
**Figure B-12. Pump SN: 16393229 Governor Assembly with 500-Hours Testing with ATJ/JP-8 Fuel**

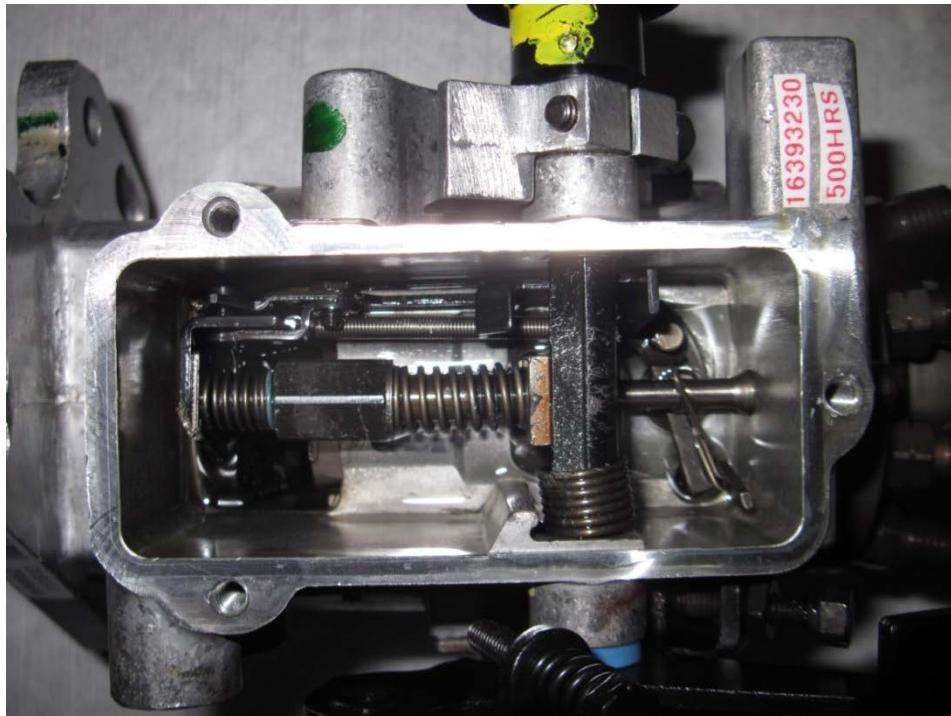
**Figure B-13. Pump SN: 16393230 Governor Assembly with 500-Hours Testing with ATJ/JP-8 Fuel**

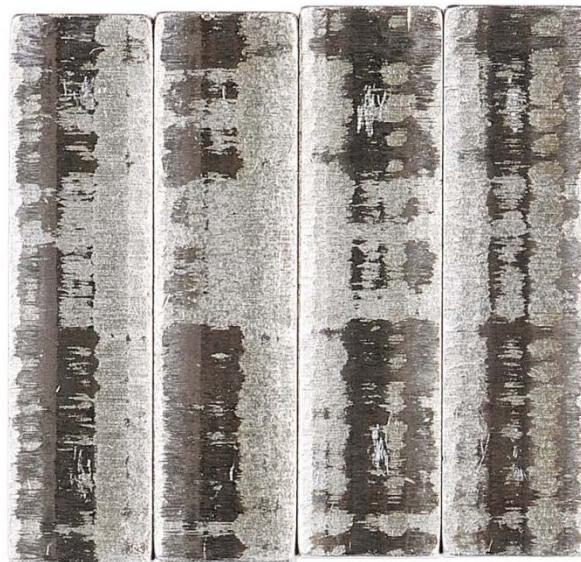
**Figure B-27. Pump SN: 16393231 Transfer Pump Blade Edges with 139-Hours Testing with JP-8 Fuel**

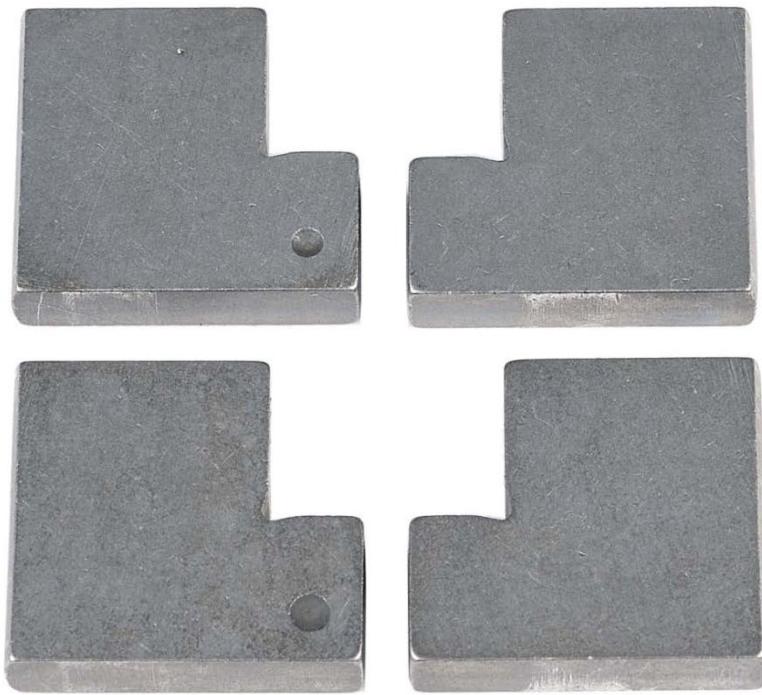
**Figure B-28. Pump SN: 16393231 Transfer Pump Blade Sides Before Testing with JP-8 Fuel**

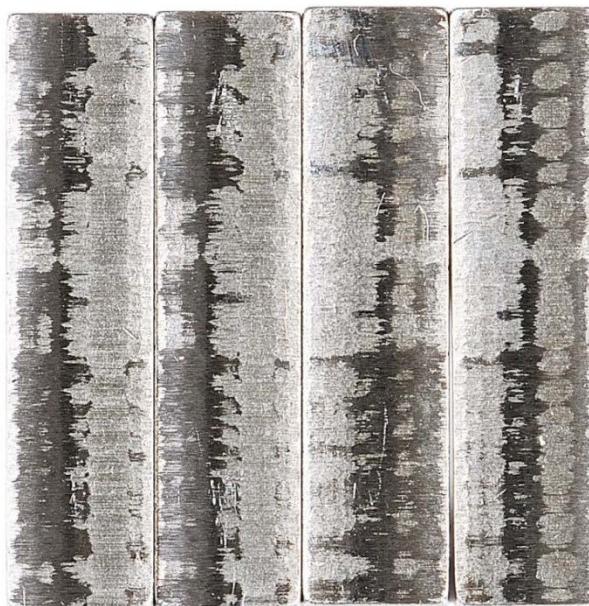
Figure B-42 and Figure B-43 illustrates the level of wear seen in the transfer pump section of fuel injection pump SN: 16393232. Figure B-42 shows the surface condition of the transfer pump liner prior to testing and Figure B-43 shows the surface with moderate scoring after 35-hours of operation on the elevated temperature JP-8 fuel. Also illustrative of wear in the transfer pump section are the transfer pump blade conditions shown in Figure B-44 through Figure B-47. The edge wear shown in Figure B-44 and Figure B-45 corresponds to the surface on the transfer pump blades that contact the transfer pump liner. The blade edge conditions in Figure B-45 reflect the scoring seen on the transfer pump liner, excessive for 35-hours operation. The light side polishing shown in Figure B-46 and Figure B-47 reflect wear from the transfer pump blade slots on the injection pump rotor. The wear seen on the transfer pump components is excessive considering the testing duration for pump SN: 16393232.

**Figure B-45. Pump SN: 16393232 Transfer Pump Blade Edges with 35-Hours Testing with JP-8 Fuel**

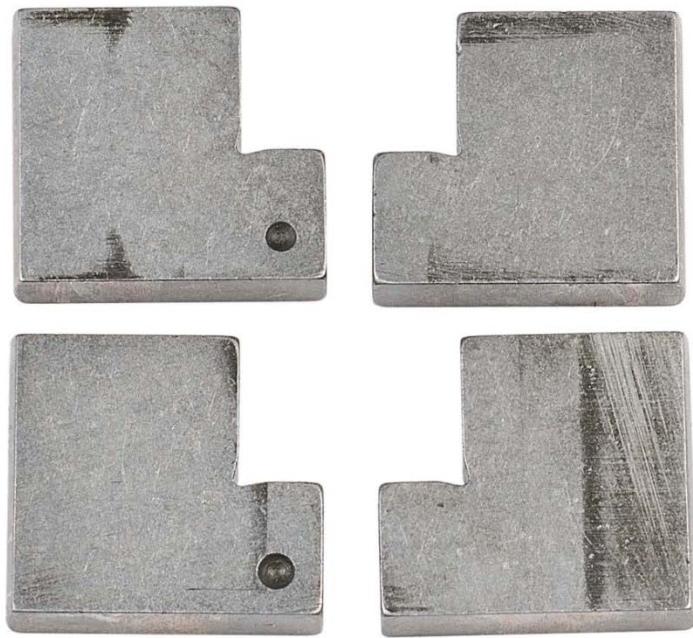
**Figure B-47. Pump SN: 16393232 Transfer Pump Blade Sides with 35-Hours Testing with JP-8 Fuel**

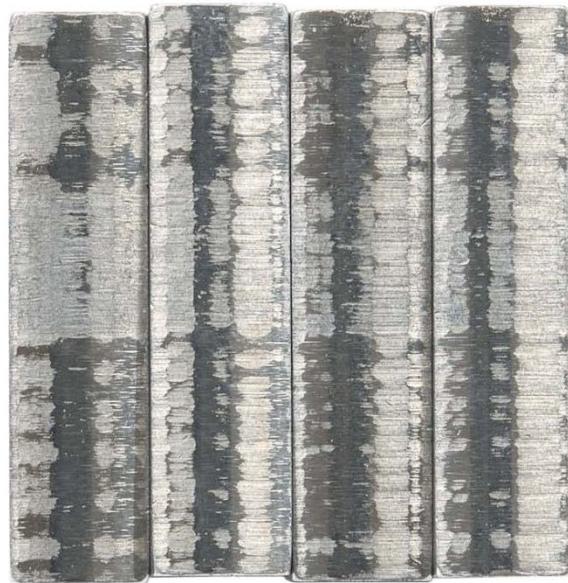
Figure B-60 and Figure B-61 illustrates the level of wear seen in the transfer pump section of fuel injection pump SN: 16393229. Figure B-60 shows the surface condition of the transfer pump liner prior to testing and Figure B-61 shows the surface with moderate circumferential scoring after 500-hours of operation on the ATJ/JP-8 fuel. Also illustrative of the transfer pump section wear are the transfer pump blade conditions shown in Figure B-62 through Figure B-65. The edge wear shown in Figure B-62 and Figure B-63 corresponds to the surface on the transfer pump blades that contact the transfer pump liner. The side polishing shown in Figure B-64 and Figure B-65 reflect wear from the transfer pump blade slots on the injection pump rotor. The wear seen on the transfer pump components of pump SN: 16393229 is similar to the elevated temperature JP-8 test, but the wear was spread out over the 500-hour duration. The transfer pump component conditions suggest the test fuel has marginal fuel lubricity.

**Figure B-63. Pump SN: 16393229 Transfer Pump Blade Edges with 500-Hours Testing with ATJ/JP-8 Fuel**

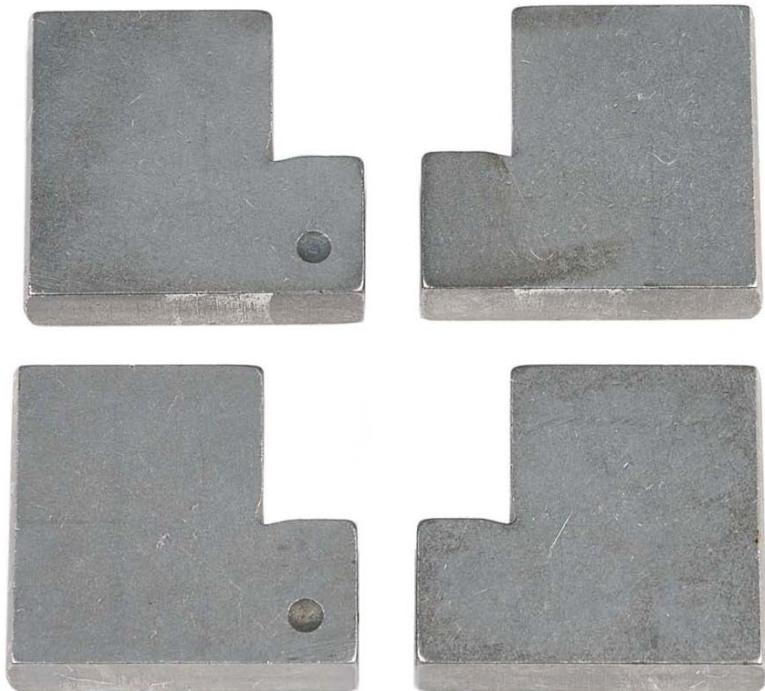
**Figure B-64. Pump SN: 16393229 Transfer Pump Blade Sides Before Testing with ATJ/JP-8 Fuel**

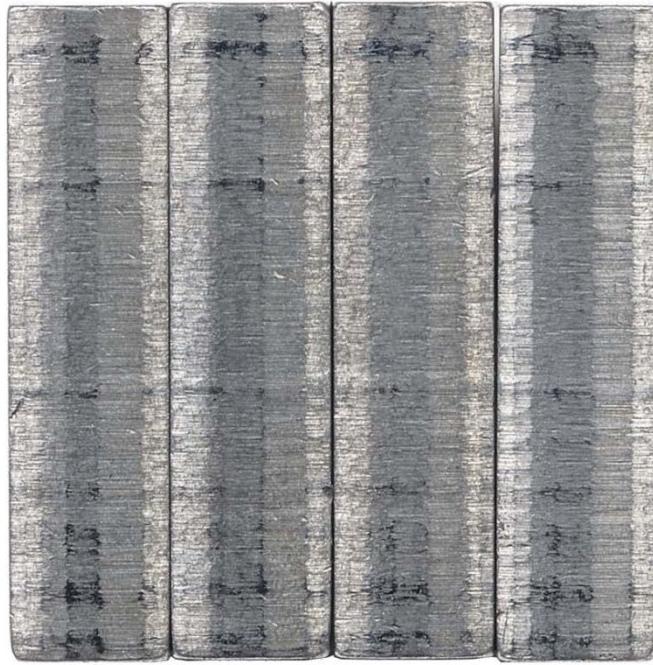
Figure B-78 and Figure B-79 illustrate the level of wear seen in the transfer pump section of fuel injection pump SN: 16393230. Figure B-78 shows the surface condition of the transfer pump liner prior to testing and Figure B-79 shows the surface with moderate circumferential scoring after 500-hours of operation on the ATJ/JP-8 fuel. Also illustrative of the transfer pump section wear are the transfer pump blade conditions shown in Figure B-80 through Figure B-83. The edge wear shown in Figure B-80 and Figure B-81 corresponds to the surface on the transfer pump blades that contact the transfer pump liner and are typical for 500-hours operation with a marginal lubricity fuel. The side polishing shown in Figure B-82 and Figure B-83 reflect wear from the transfer pump blade slots on the injection pump rotor. The wear seen on the transfer pump components of pump SN: 16393230 is similar to the elevated temperature JP-8 test, but the

wear was spread out over the 500-hour duration. The transfer pump component conditions suggest the test fuel has marginal fuel lubricity, also evidenced by the variation of transfer pump pressures noted during testing.

**Figure B-79. Pump SN: 16393230 Transfer Pump Liner with 500-Hours Testing with ATJ/JP-8 Fuel**

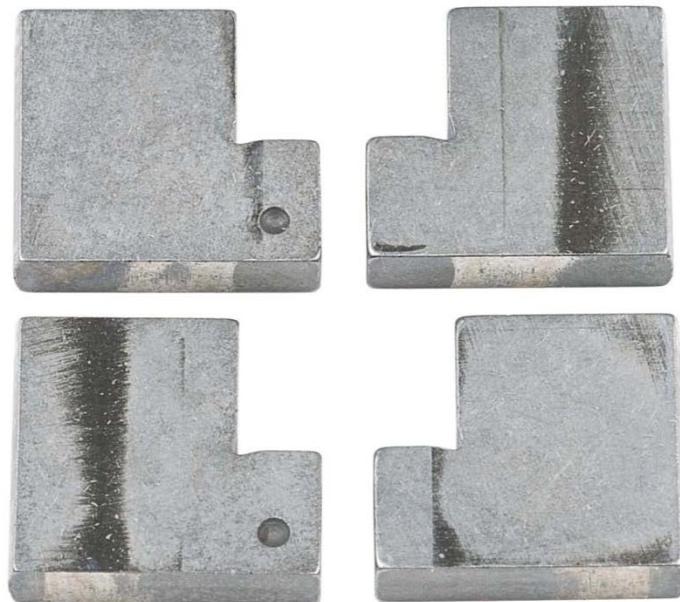
**Figure B-83. Pump SN: 16393230 Transfer Pump Blade Sides with 500-Hours Testing with ATJ/JP-8 Fuel**

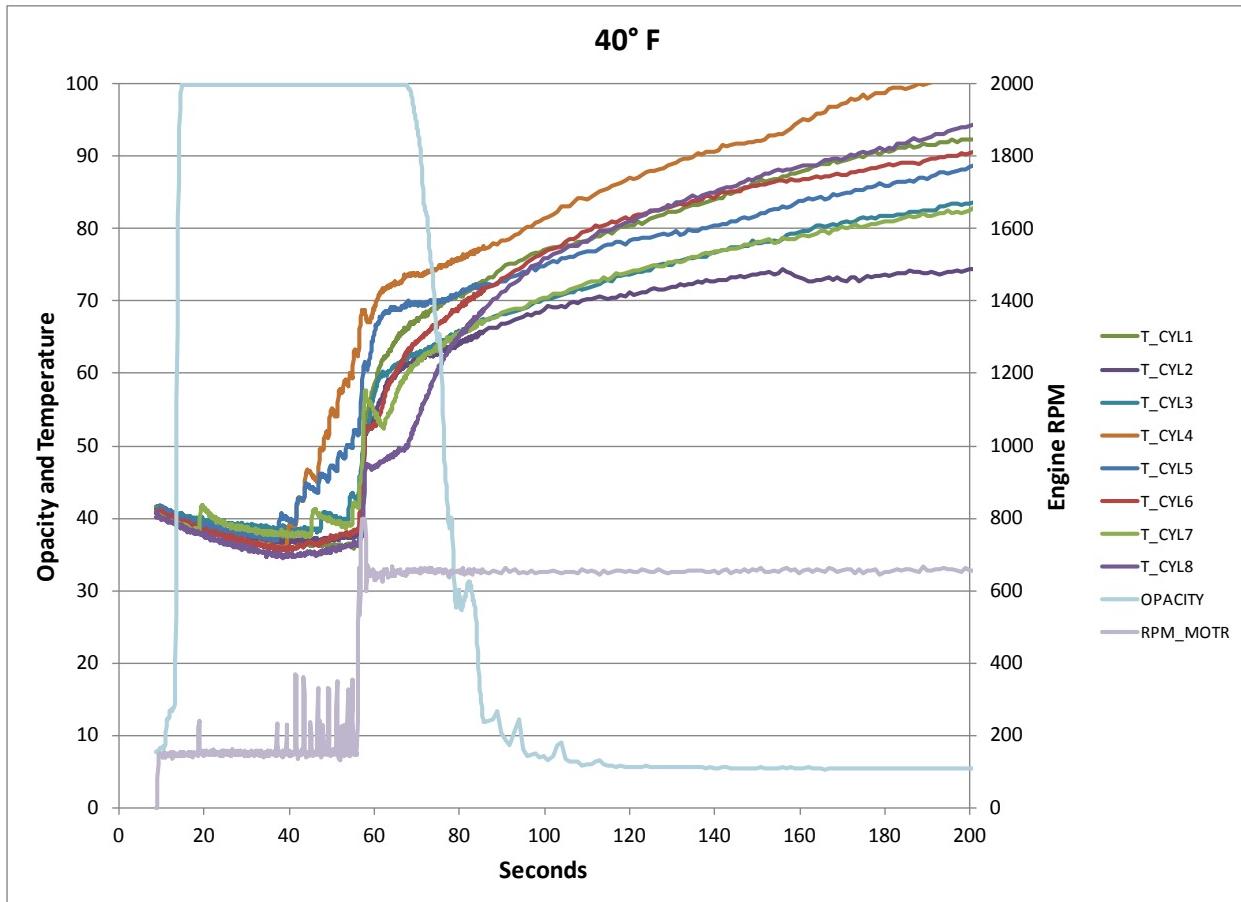
Figure C-12. High Cetane Cold Start at 40 °F

At 40 degrees Fahrenheit, the engine was able to start without the aid of glow plugs. However, as seen in Figure C-12, the engine was firing intermittently on 4 cylinders before fully starting. A few seconds after starting, the engine was able to achieve a steady rpm. Cylinders 7 and 8 were the last to fire continuously, and the opacity decreased rapidly to zero once combustion stabilized.
